Winter Contaminants on Surfaces During Friction Tests at Munich Airport - February 2000

LTR-SMPL-2000-0234
TP 13658E

N.K. Sinha

September 2000

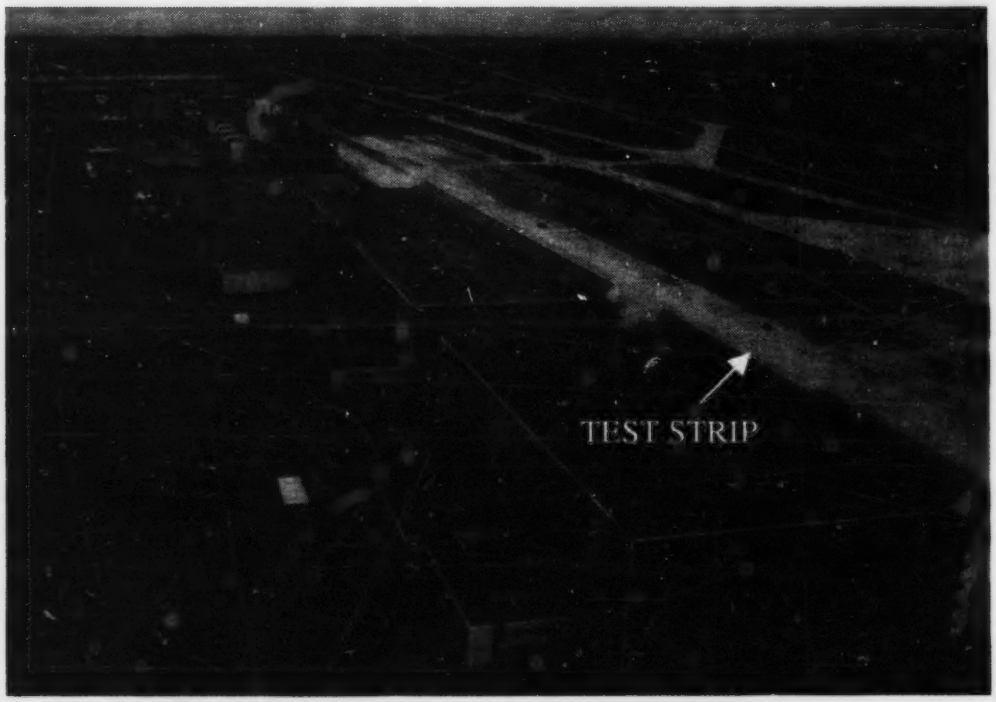
Figure 3. An aerial view, looking towards the 08 direction of the test strip (600 m x 20 m) on the maintenance ramp between the hangars and the 08-26 runway on the right

The air temperature was just above the freezing point at this time. The operation of building a man-made snow cover on the concrete surface of the test strip (600 m x 20 m) was very impressive. A number of hauling trucks brought moist and dense (density of about 700 $kg.m^{-3}$) snow from the storage area. This moist and compacted snow was dumped on the concrete surface along a row parallel to the length of the test strip. This row was about 20 m south of the runway side of the intended test strip (Figure 2). A powerful snowblower was then used to spread the snow on the test strip. It took about two hours to cover the entire test area with a layer of snow about 20 mm in thickness. After completion of the task of spreading, excess materials on both sides of the planned test strip were removed, leaving a stretch of groomed material on the test strip. An example of a man-made test bed of processed and stored snow can be seen on the right side (runway side) of the hangars in Figure 3.
